UNDERWATER BRIDGE INSPECTION REPORT

STRUCTURE NO. 27554

CROW RIVER

DISTRICT 5 – HENNEPIN COUNTY

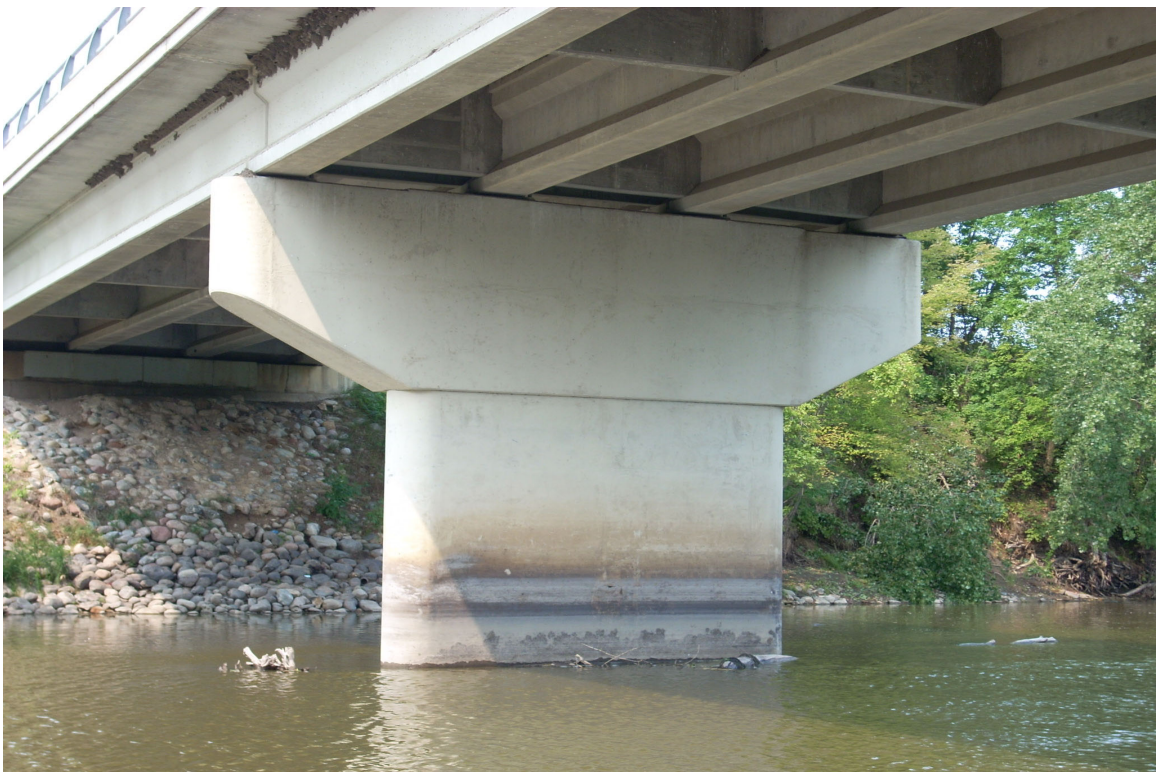
- (A) The top of footing was exposed at 2.7 feet below the waterline around Pier 1 with up to 8 inches of vertical exposure at the southeast corner.
- (B) The grouted cobbles (rip-rap) that were to protect the East Abutment exhibited heavy erosion with up to 75 percent loss of cobbles.

- (C) The concrete of both Piers 1 and 2 was found to be generally smooth and sound.
- (D) A moderate accumulation of timber debris consisting of logs up to 18 inches in diameter was located around the entire pier shaft of Pier 1. The timber debris extended from the channel bottom up to 1 foot above the waterline, 5 feet off of the faces, 20 feet off of the upstream nose, and 5 feet off of the downstream nose.

Photograph 2. View of Pier 1, Looking Northwest.

- (A) Remove the timber drift that has accumulated around the piers including the large logs on the channel bottom at both piers, which could contribute to scour and footing exposure.
- (B) Monitor footing exposure at Pier 1 during future underwater inspections.
- (C) Repair and/or replace the grouted rip-rap erosion protection at the East Abutment.
- (D) Reinspect the submerged substructure at the normal maximum recommended (NBIS) interval of five (5) years.

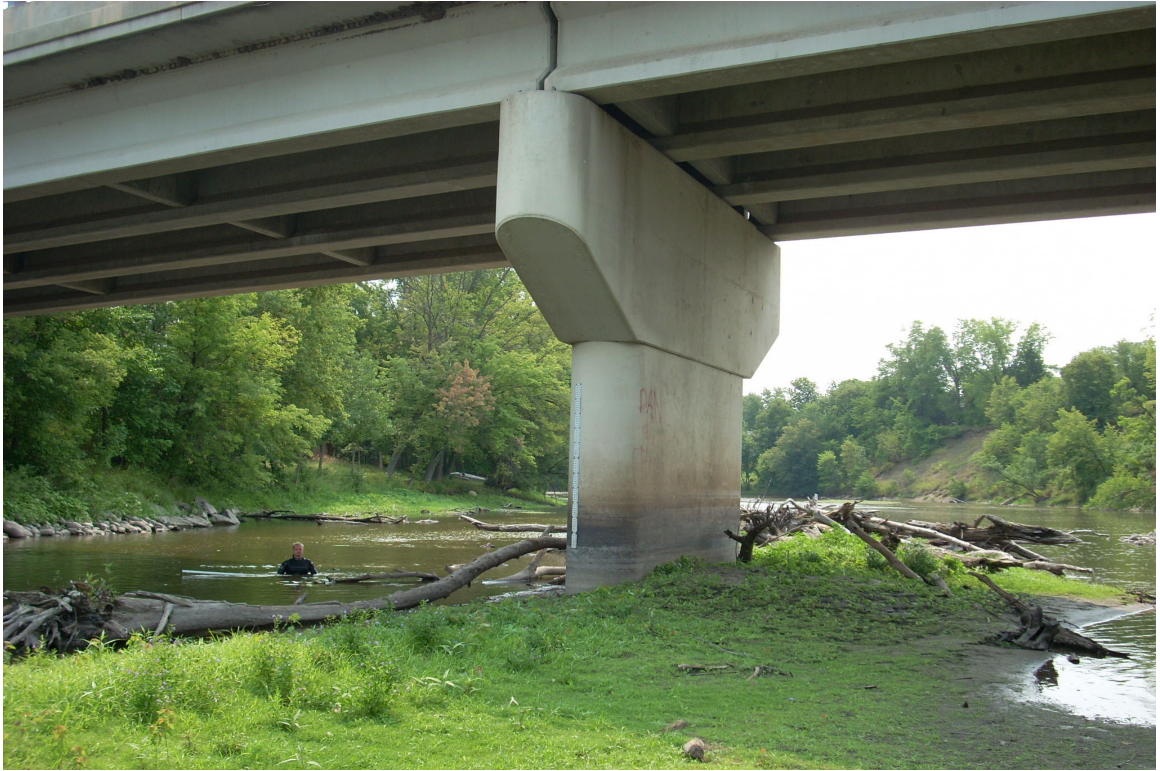
Photograph 3. View of Pier 2, Looking Southeast.

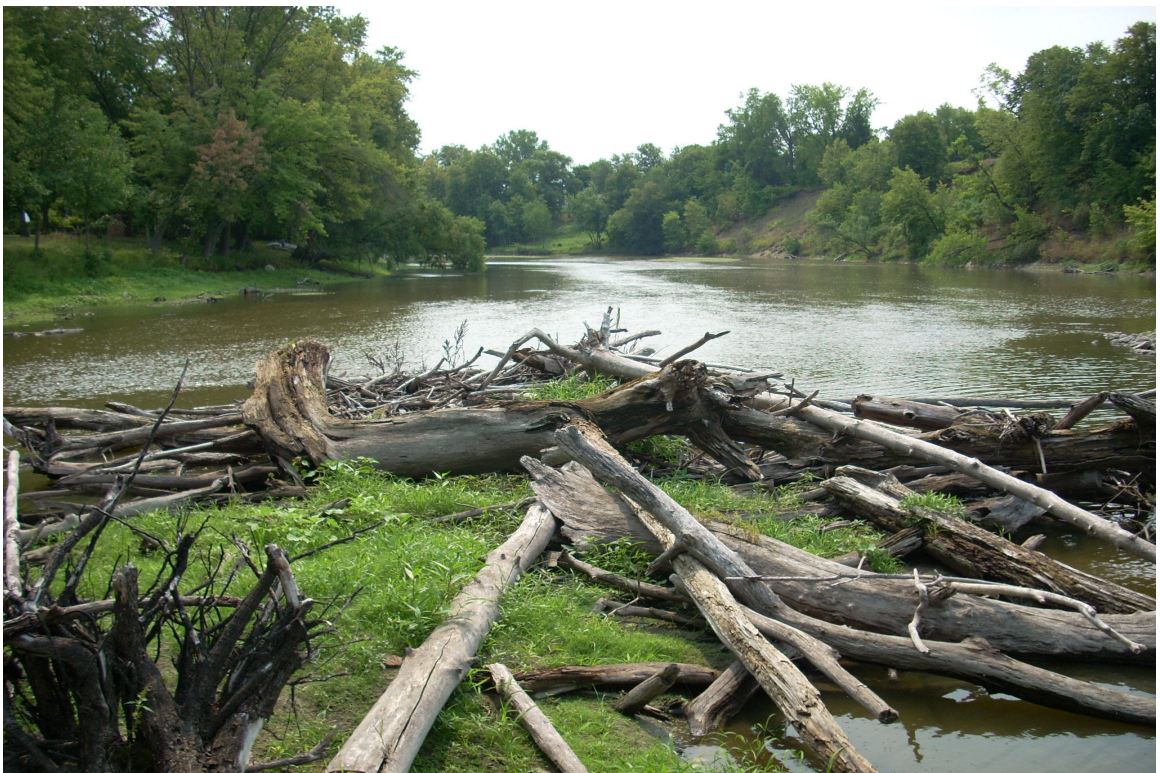
- (E) Along both side faces and around the upstream nose of Pier 2, a heavy accumulation of timber debris was observed. The debris extended from the channel bottom up to 3 feet above the waterline, 10 feet off of the pier faces, and 30 feet off of the upstream nose.

Photograph 4. View of Timber Debris at Pier 2, Looking South.

- 7 A heavy accumulation of timber debris consisting of 24-inch-diameter and smaller logs and branches was observed at the upstream nose and along both faces of Pier 2. The debris extended from the channel bottom to 3 feet above the waterline, 10 feet off of the pier faces and up to 30 feet off of the upstream nose.

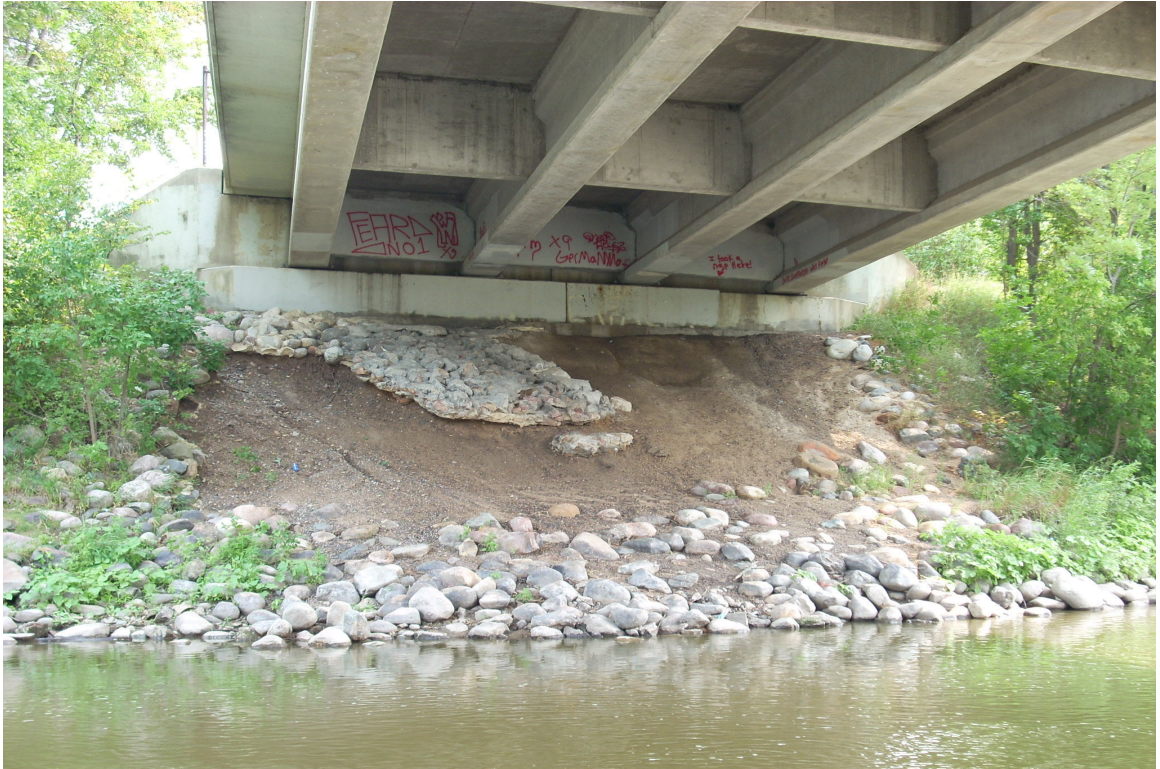
Photograph 5. View of heavy erosion of Grouted Rip-Rap at East Abutment, Looking East.

- 3 The channel bottom consisted of silt at Pier 2 with up to 2 feet of probe rod penetration.
- 4 Concrete of both Piers 1 and 2 was smooth and sound.
- 5 The grouted rip-rap, up to 18 inches in diameter, that protected the East Abutment exhibited heavy erosion with up to 75 percent loss of cobbles.

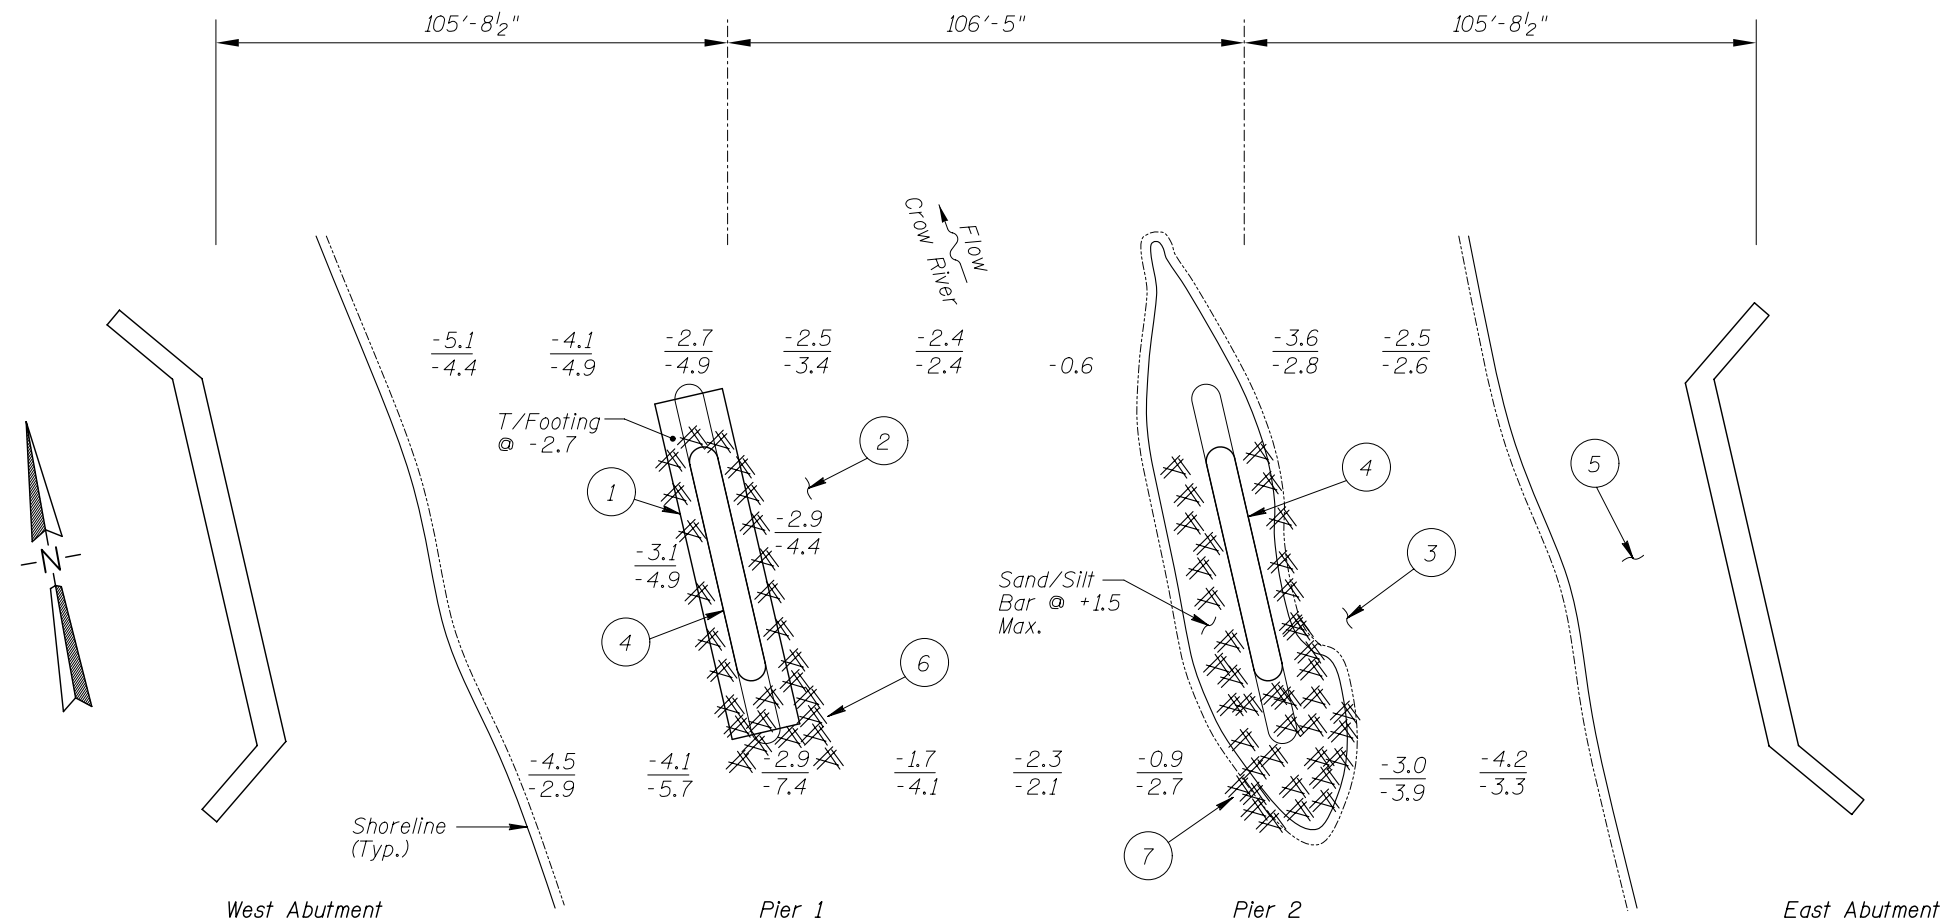
INSPECTION AND SOUNDING PLAN

- 1 The top of footing was exposed at 2.7 feet below the waterline around Pier 1 with up to 8 inches of vertical exposure at the southeast corner.
- 2 The channel bottom consisted of sand at Pier 1 with up to 6 inches of probe rod penetration.

- 6 A moderate accumulation of timber debris consisting of logs up to 18 inches in diameter was located around the entire pier shaft of Pier 1. The debris extended from the channel bottom to 1 foot above the waterline, 5 feet off of the faces, 20 feet off of the upstream nose, and 5 feet off of the downstream nose.
